LESSONS LEARNT IN THE ACCESSIBILITY OF WATER POINTS AND INSTITUTIONAL LATRINES THROUGH PHOTOS AND PRACTICAL EXAMPLES FROM THE FIELD

This short document is based on the COWASH FTAT Disability Inclusion Specialist visiting all the 5 COWASH regions and 40 woredas over the last years (2018-2020) for monitoring and assessing the accessibility of WASH facilities, both for communities and institutions. During these visits, many good examples of nicely constructed accessible facilities were seen, but there are also many similar mistakes or forgotten issues in many places. In order to learn from each other and to improve further in the future, in this document are listed some of the most common problems as well as some good examples for the reference of both the COWASH RSUs as well as all the woredas. The document is not meant to be about finding mistakes or those who have not done well, it is about finding solutions, learning and avoiding repeating the same faults again. This is why it is not specified from where each picture is. In all of the sites the aim was to make them accessible, so it is not a collection of bad examples, but a collection of many attempts of making WASH facilities a

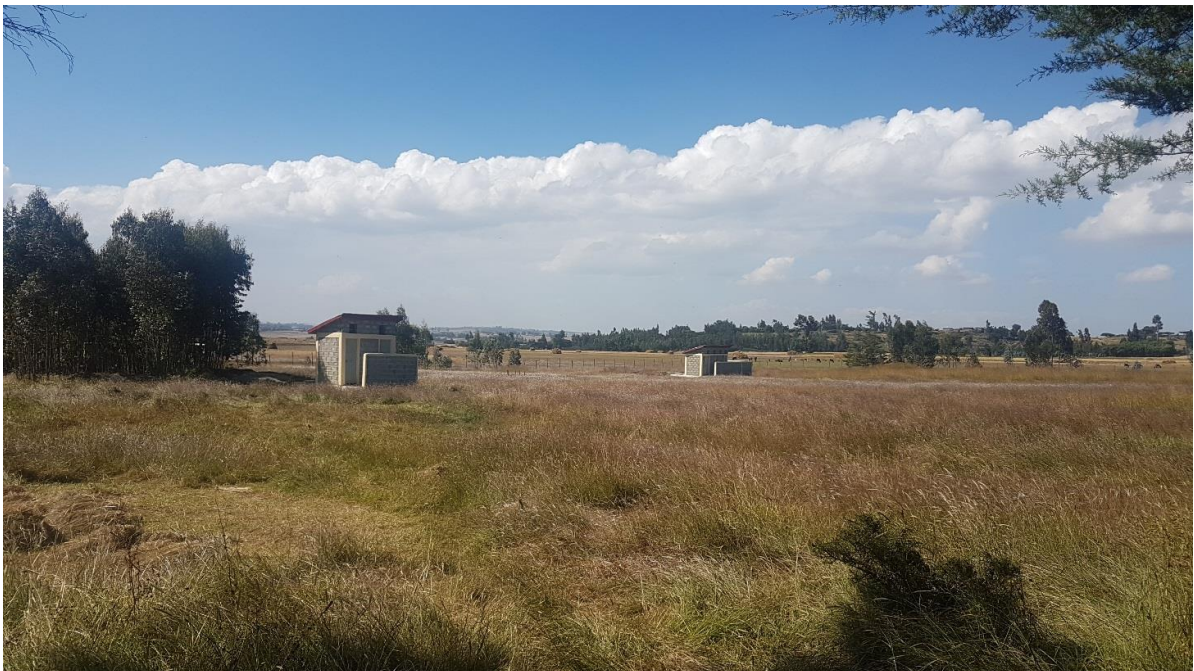
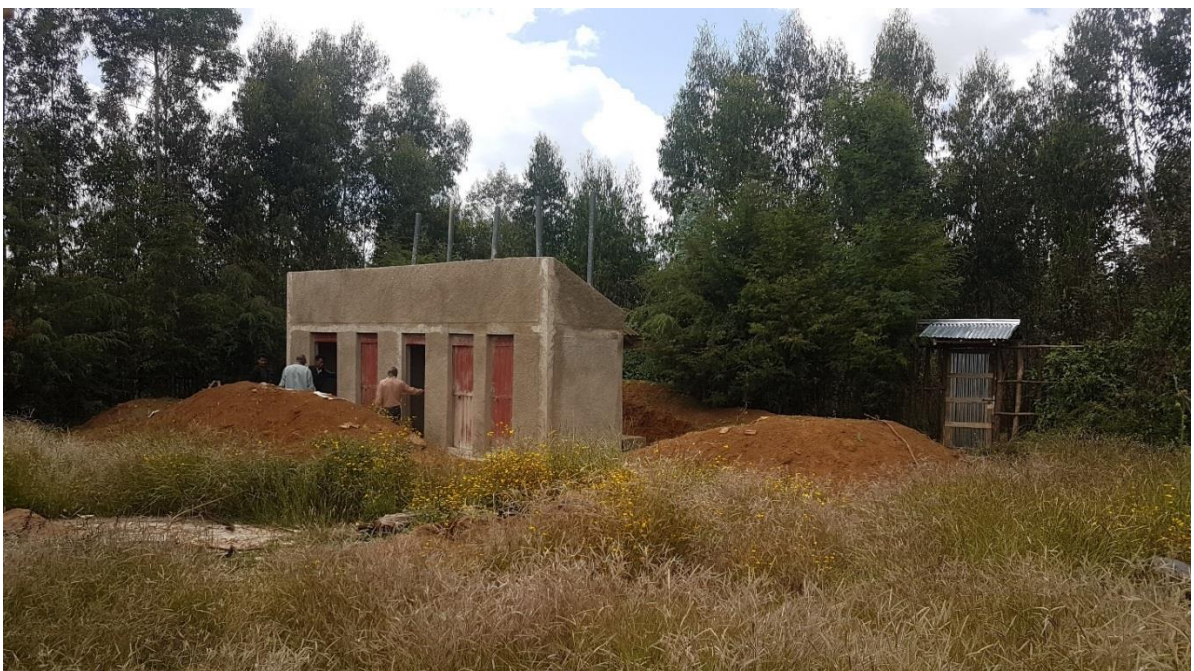
1.1. THE MISSING PATH AND LONG DISTANCE TO THE FACILITY

Oftentimes the first hurdle is the path and the distance to the WASH facility itself. Sometimes due to topography or site selection it is difficult or impossible to solve this issue. However, many times especially so in institutions, it is not a difficult issue to solve. In the institutions the latrines should not be placed too far away (minimum 6 metres and maximum 30-50) and the construction materials should not be left there to block the way. Especially in schools where there are students with disabilities the way to the facility should be checked together with them.

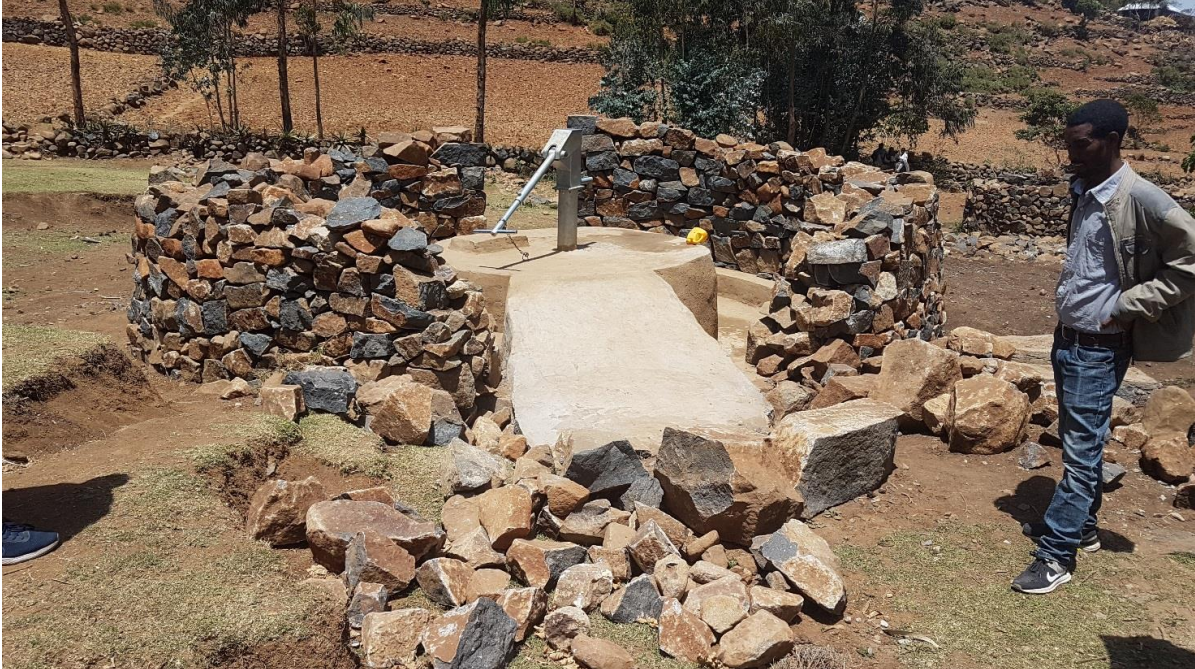
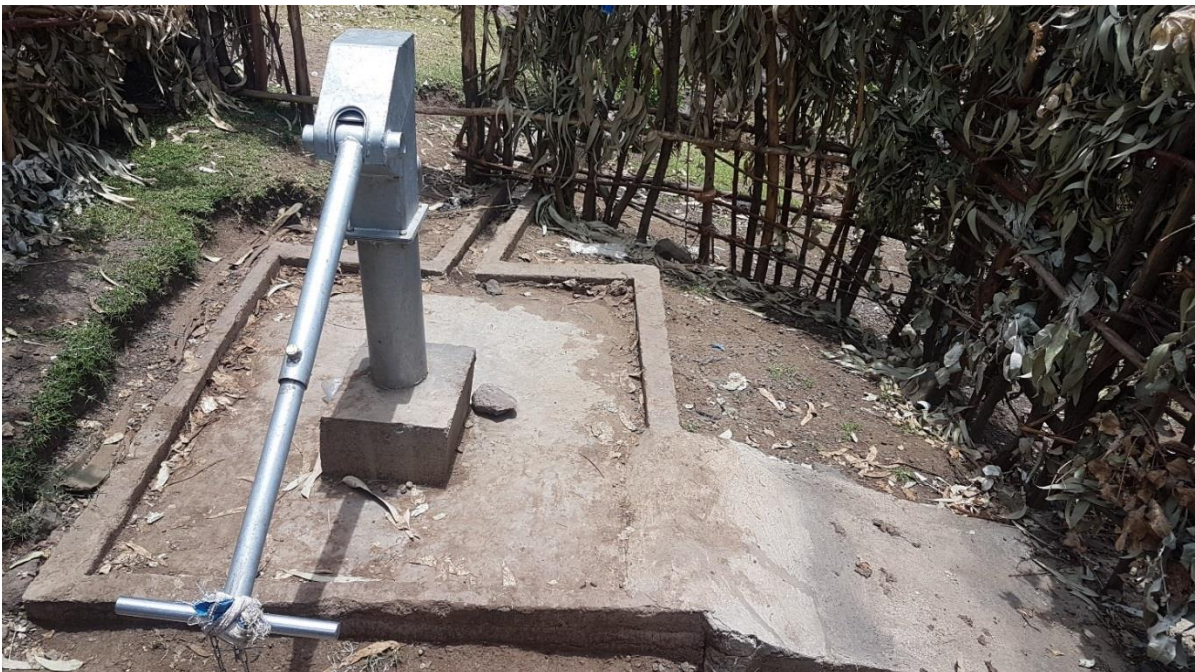
1.2.1. Is blocked by the fence

It is common to see that the ramp is blocked by the fence or other obstacles, making it impossible to use it. The fence door should always be placed in front of the ramp.

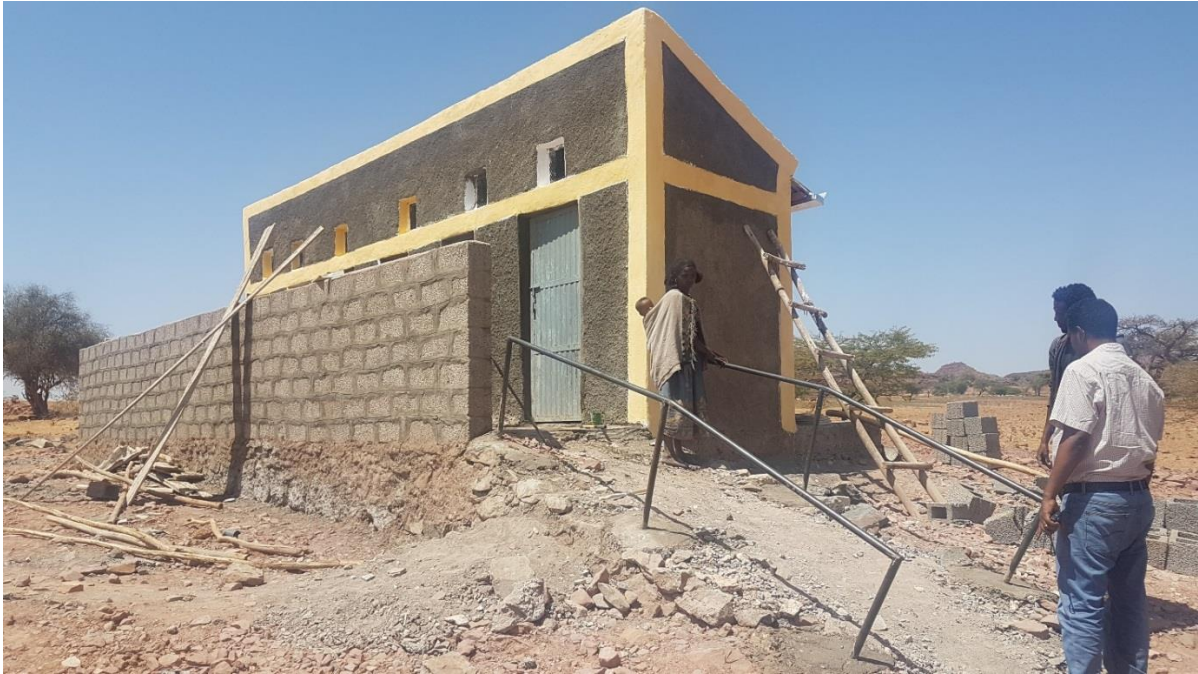
1.2.2. Is too steep, has no support handles or the handles are too low to be useful

Often it is not possible to use the ramp as it is made too steep. The ramp should have a maximum slope of 10%, ideally 6-8%. If the slope is steep support handles should be added. The handrail should be high enough (70-90 cm) to be useful.

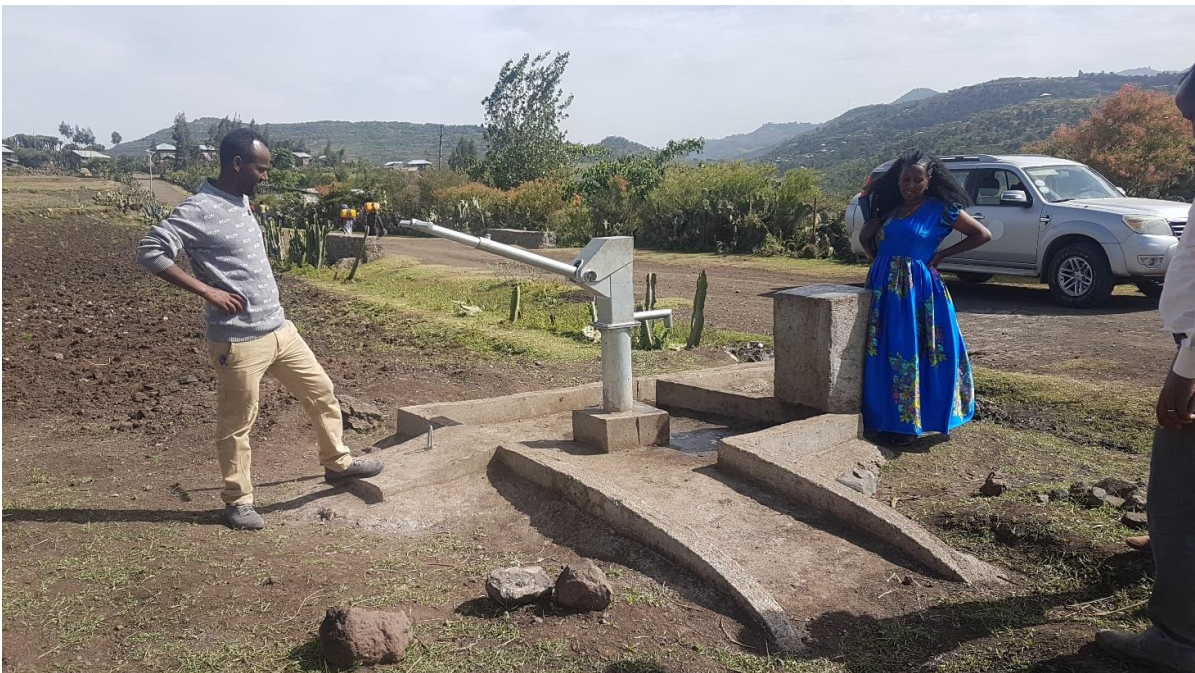
1.2.3. Does not lead to the correct place

The purpose of the ramp is to get easy access to the facility. At times the ramp has been constructed, but it does not allow access to the water point or the latrine.

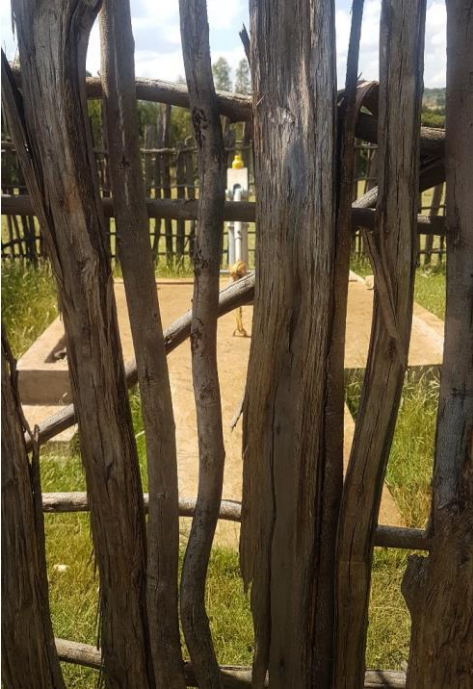
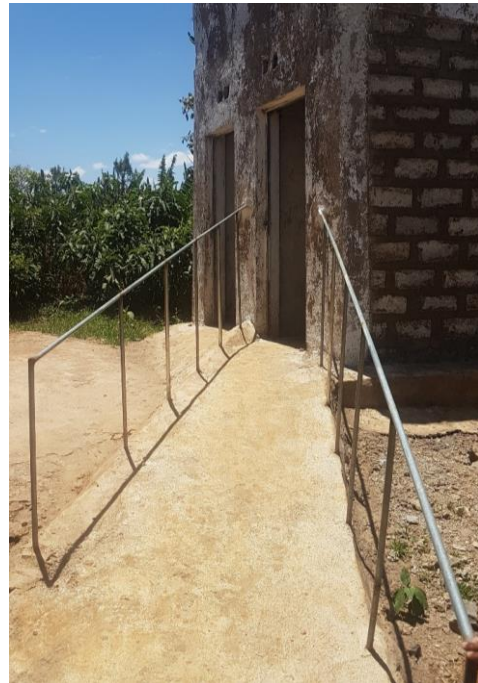
1.2.4. Is not in the logical direction or not straight

The ramp and the entrance should be located on the logical way from the institution or village. Sometimes it is built on the wrong side of the building or water point, not taking into account from which direction the users are coming from. The ramp should also always be straight, not built at a diagonal.

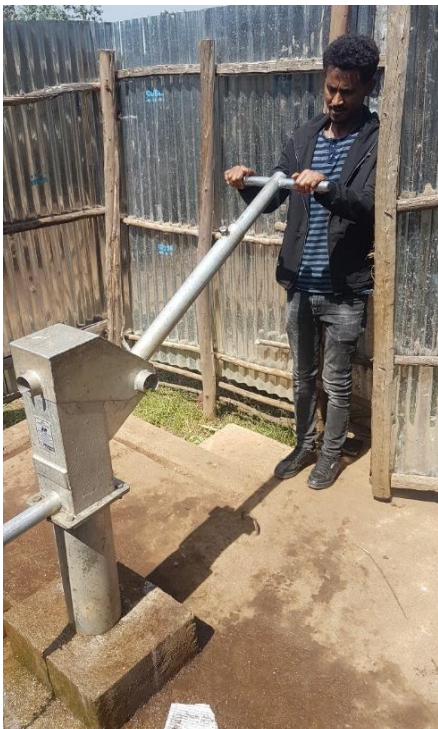
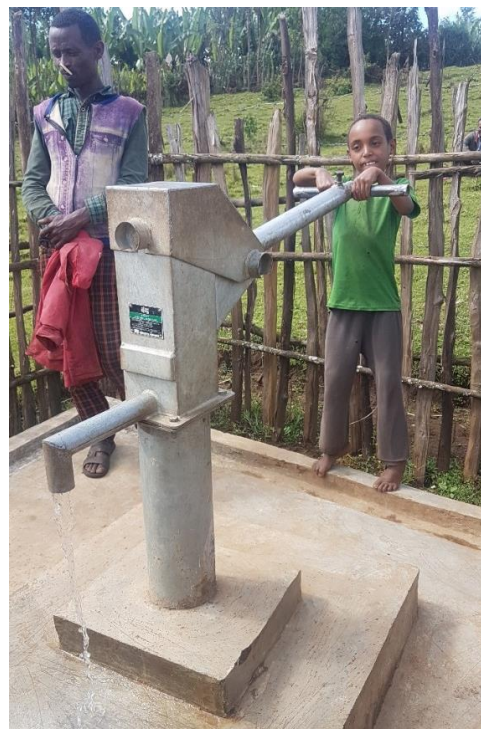
2.1. THERE IS NOT ENOUGH SPACE TO USE THE PUMP HANDLE

This is a very common problem that is easy to fix, but one that makes a big difference to all users.

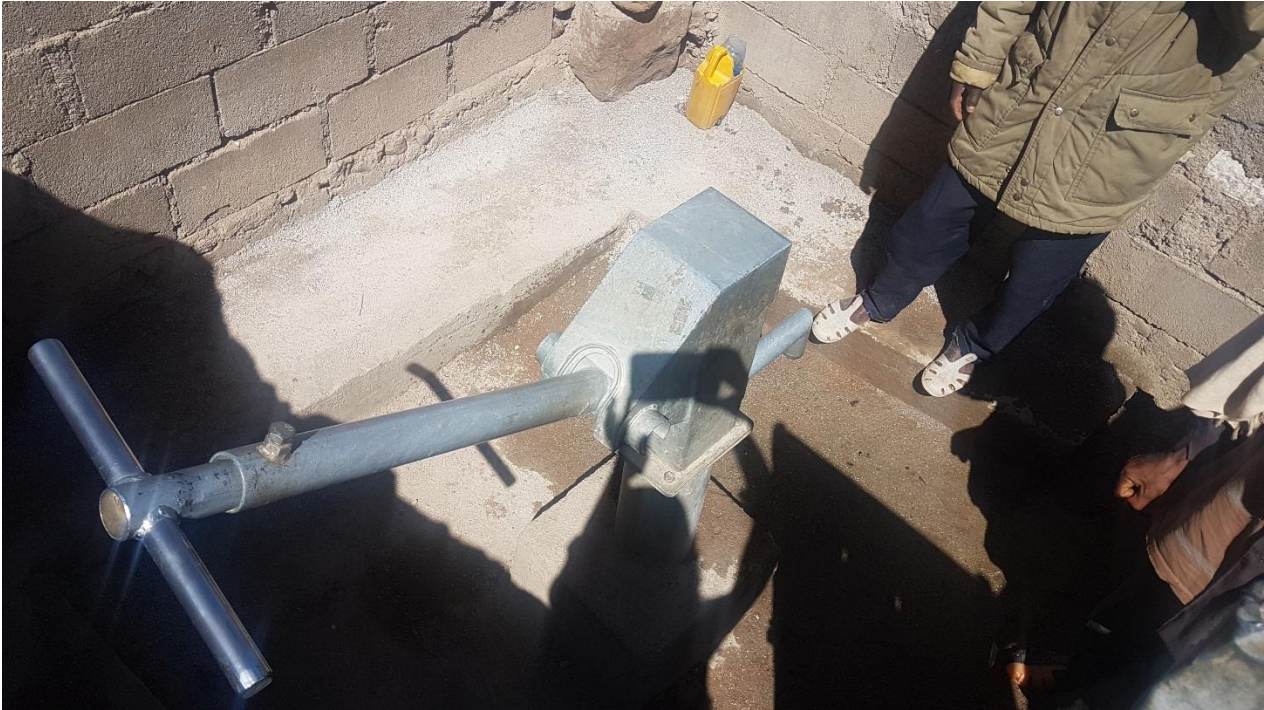
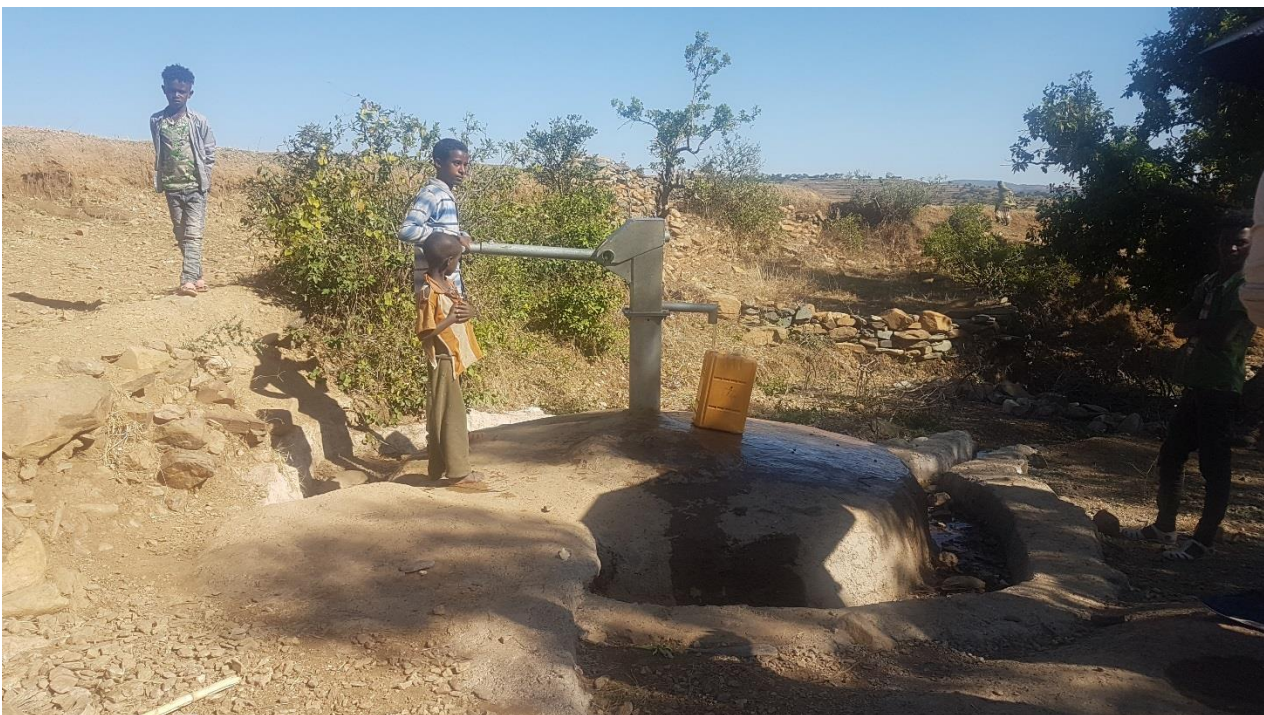
2.2. THERE IS NOT ENOUGH SPACE TO MOVE AROUND ON THE HEADWORK OR THE HEADWORK IS NOT EVEN

It is better for all users if there is enough space to move around the water point or if the surface is even, but it is essential for persons with disabilities.

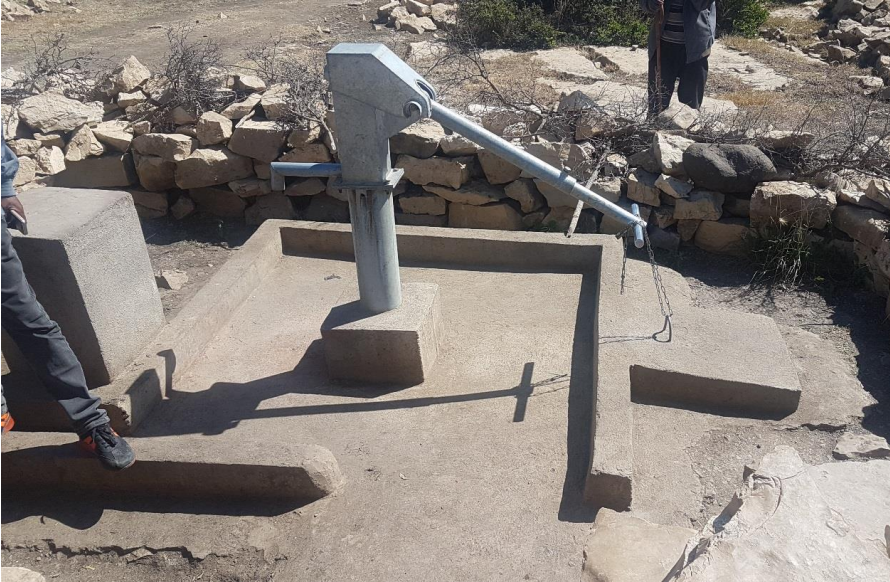
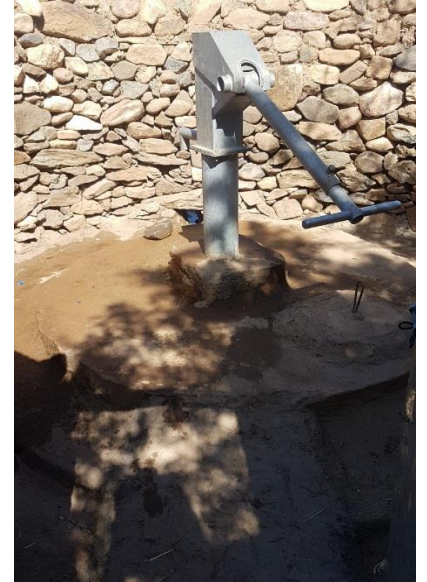
2.3. IT IS NOT POSSIBLE TO REACH BOTH THE PUMP HANDLE AND THE JERRY CAN

This is also a common problem that is usually the result of not thinking about how the water point will be used by the people. However, it is necessary for all the reach both the pump handle and the jerry can. For this all the surface of the headwork needs to be even and smooth.

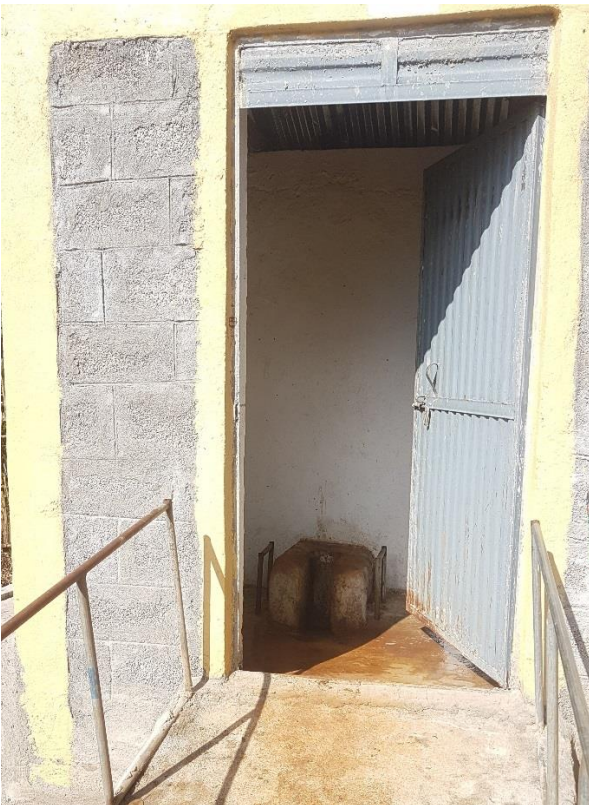
3.1. THE DOOR OPENS TO THE INSIDE OR THE DOOR OPENS TO THE OUTSIDE BUT BLOCKS THE ENTRY TO THE CUBICLE AS IT OPENS TOWARDS THE PERSON

When the door opens to the inside once you have entered the room with the wheelchair, it is impossible to close it (unless the room is made much bigger, but that would not make any sense). Therefore it has to open to the outside.

However care should be also be put in the direction of the door opening (left or right) depending on the site. The door should not block the user when entering to the facility – it should not open towards the person but away from the person.

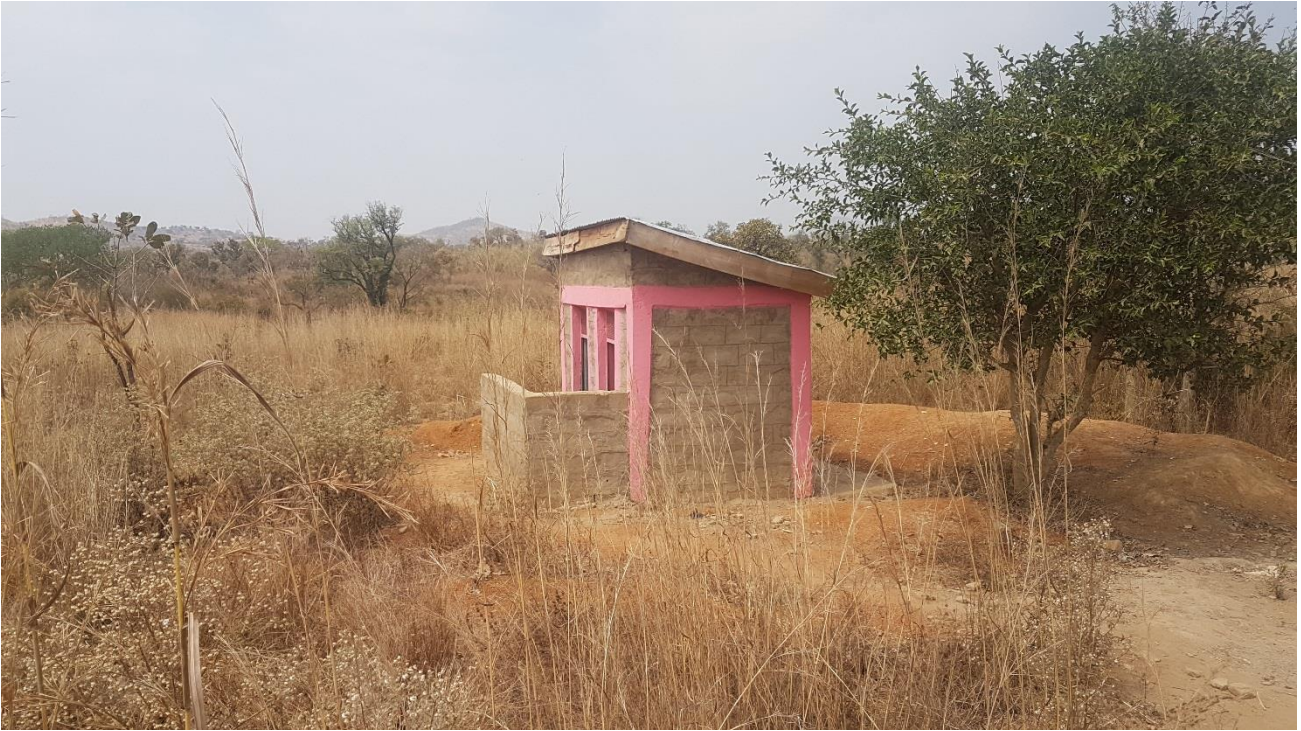
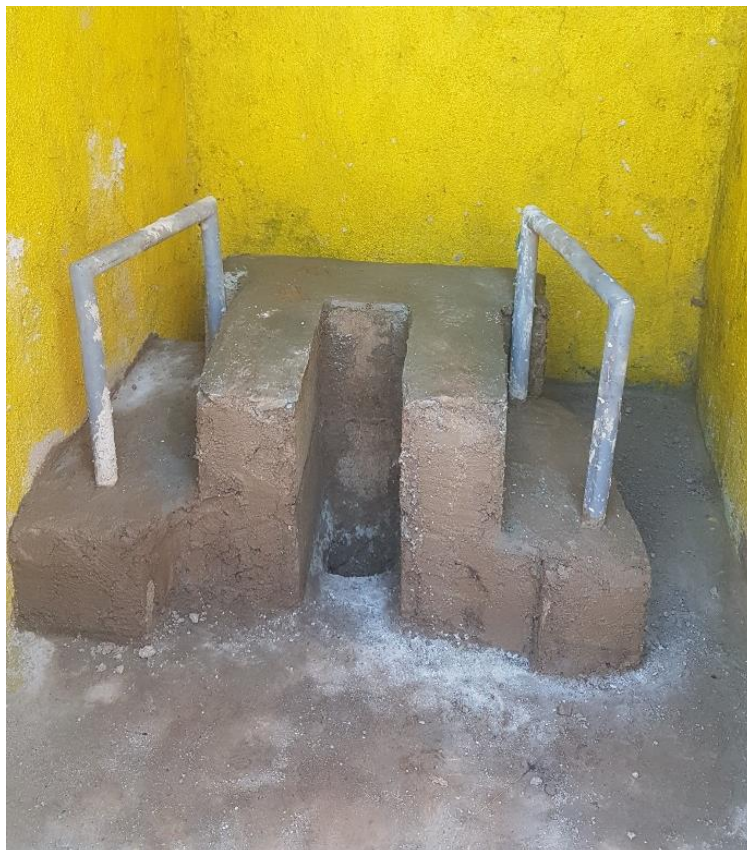
3.4. THE ENTRANCE IS NOT ON THE LOGICAL OR CLOSEST SIDE OF THE LATRINE BLOCK, MAKING ENTRY DIFFICULT AND THE WAY THERE UNNECESSARY LONGER

The entrance should be placed on the side that is nearer to the institution, not the other side to make sure entry is easy and the way there as short as possible.

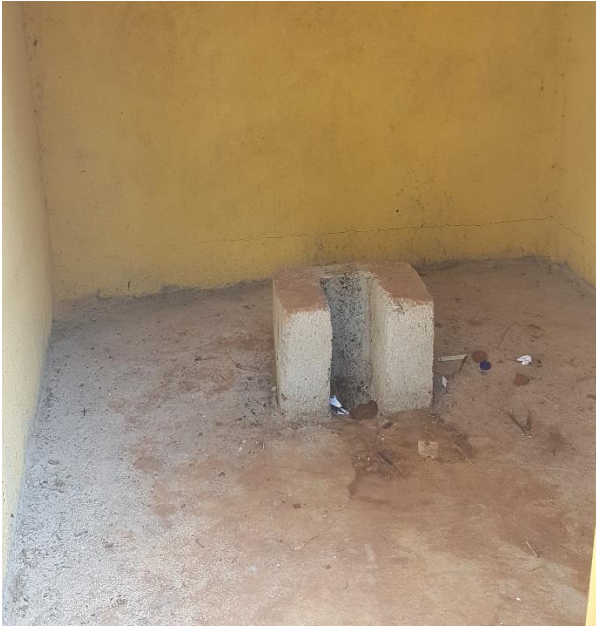
3.5. THERE IS NOT ENOUGH SPACE TO MOVE AROUND THE CUBICLE OR FOR A WHEELCHAIR OR ASSISTANT

The accessible cubicle has to be bigger than the other cubicles to make sure there is space for a wheelchair or for an assistant. This means minimum 1.5 x 2 metres.

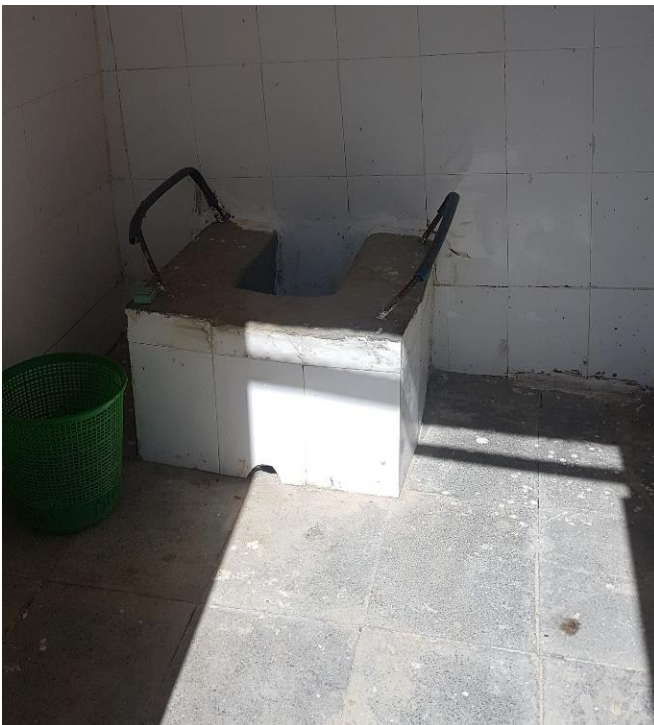
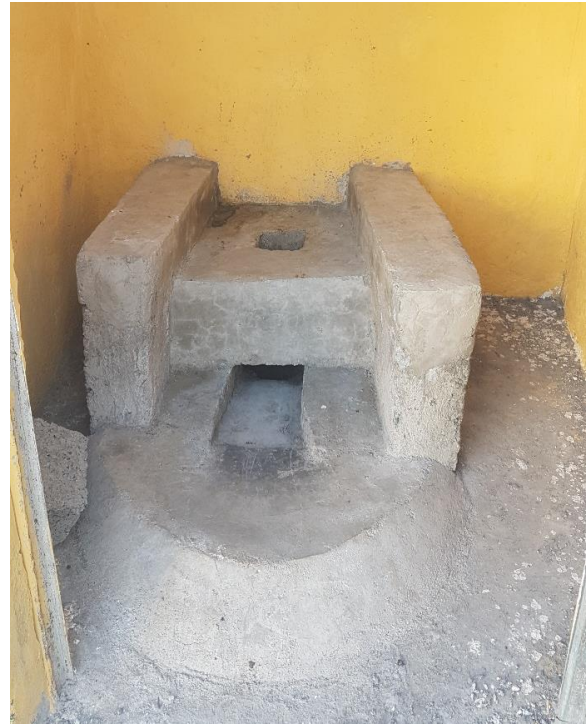
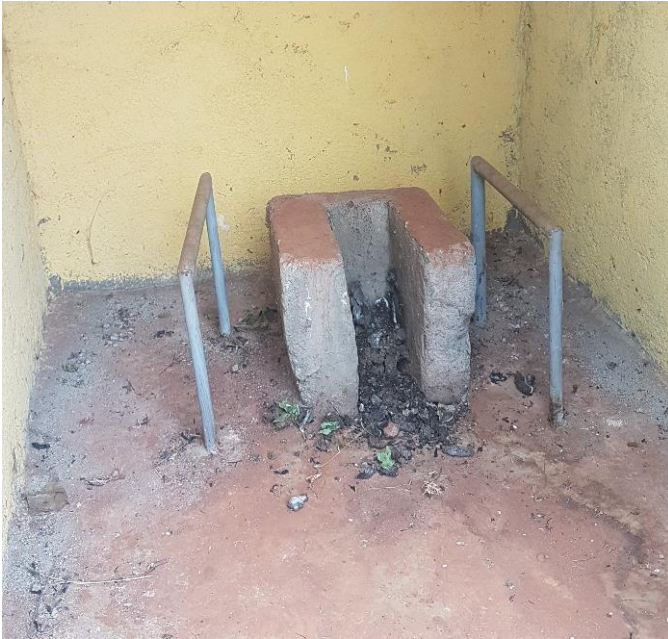
3.7. THERE IS NO RAISED SEAT OR THE SEAT IS NOT CONVENIENT / PRACTICAL TO USE

For many persons with physical disabilities it is necessary to have a seat as they may have difficulties squatting or otherwise they may have to crawl or sit on the floor, which is very unhygienic. The seat can be made of different materials but it is better if the seat is open from the front for more practical urination and the surface should not be too rough. The hole in the seat should also be big enough. Contractors and artisans should be encouraged to sit or test it themselves to get it right. In schools it should be considered if the users are small children.

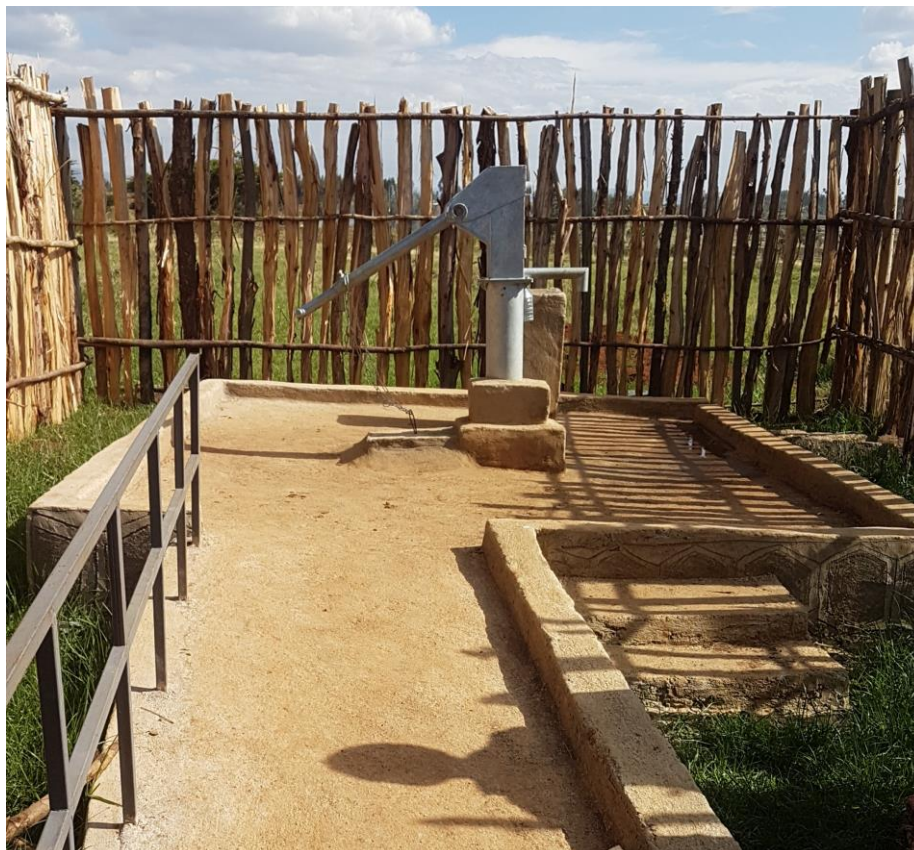
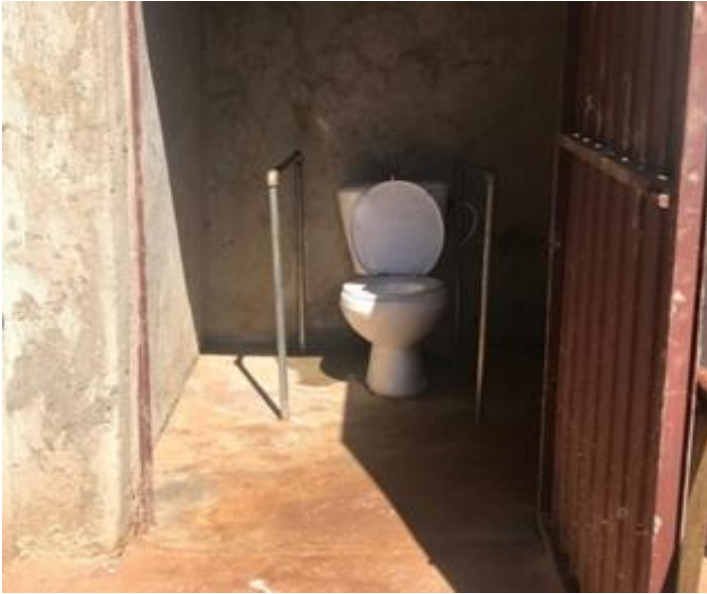
This is one good example of a community hand dug well. There is a ramp, which is placed in the correct place, is not too steep and has a handrail for support. There is enough space to move around and it possible to reach both the pump handle and the jerry can. There are no obstacles and the surface is smooth.

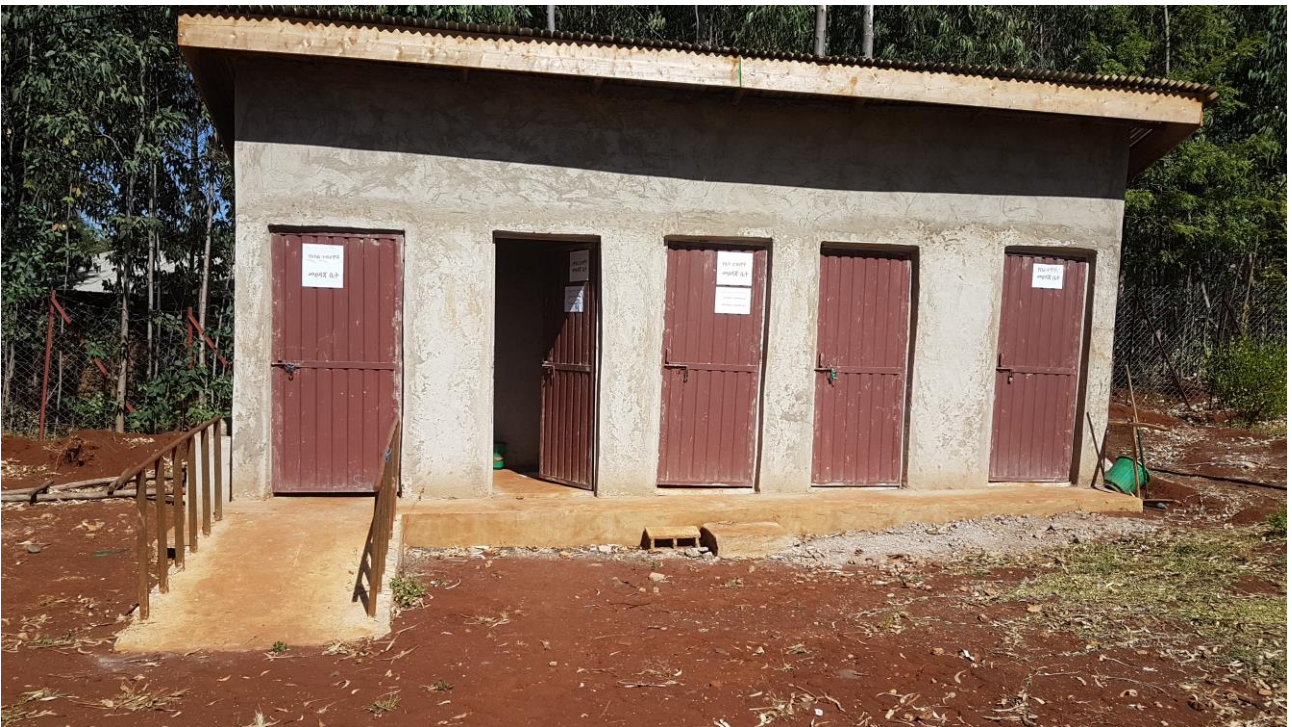
This health centre latrine is located near to the institution and the area/ path is clear. The ramp leads to the cubicle and is not too steep and has a supporting handrail. The door opens to the outside and the entrance is smooth, flat and big enough. There is a flush toilet seat (which is possible as the health centre has a water point and working piped connection to the toilet). There is also handrails next to the seat (a little too high however). The toilet is also kept clean.
