ASSESSMENT OF THE COMMUNITY MANAGED PROJECTS (CMP) APPROACH IN DEVELOPING RURAL WATER SUPPLY SCHEMES:

A CASE OF PAWE AND MANDURA WOREDAS, NORTH EASTERN PART OF BENISHANGUL GUMUZ REGIONAL STATE, Ethiopia

A Thesis by

Civil Engineering Department, November 2012

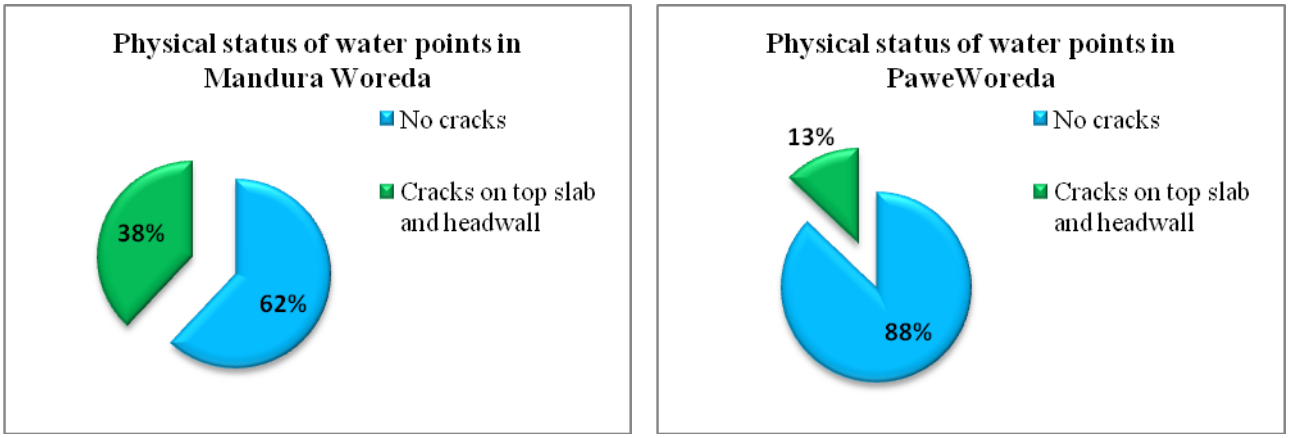
The quality of construction is crucial for sustainability of schemes. Most of the visited schemes are built with good quality except 37.5% of the surveyed hand-dug wells in Mandura and 12.5% in Pawe, which had cracked slab covers. Cracks can make the well vulnerable to bacteriological contamination if not maintained immediately. The cracks seem to be caused due to loose foundation underneath. This shows that supervision from communities and woredas during construction was not adequate.

Figure 17: Percentage of water points where cracks were observed

Figure 18: Cracks on head wall and top slab

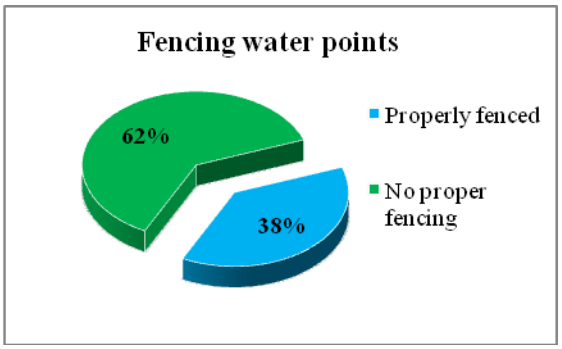
Protection of water sources and facilities after construction is an important factor for sustainability of schemes. From the field observations, **25%** water points in Mandura and **87.5%** in Pawe woredas have employed guards to protect the source from misuse and damage. In addition, in **100%** and **50%** of visited schemes in Mandura and Pawe respectively, fencing work is not properly done or it is non-existent at all.

Figure 20: Percentages showing fencing water points

Figure 21: a. Water point with no fence at all, b. poor fencing and c. good fencing respectively

It was also observed that, most of the ditches around water points were filled with mud and not draining spilled water properly. And the table 10 shows percentage of surveyed schemes, which had swampy surroundings, creating breeding sites for mosquitoes.
